INDOOR AIR QUALITY ASSESSMENT

**Watertown Fire Department Headquarters
99 Main Street
Watertown, Massachusetts**

Prepared by:
Massachusetts Department of Public Health
Center for Environmental Health
Bureau of Environmental Health Assessment
Emergency Response/Indoor Air Quality Program
February 2005

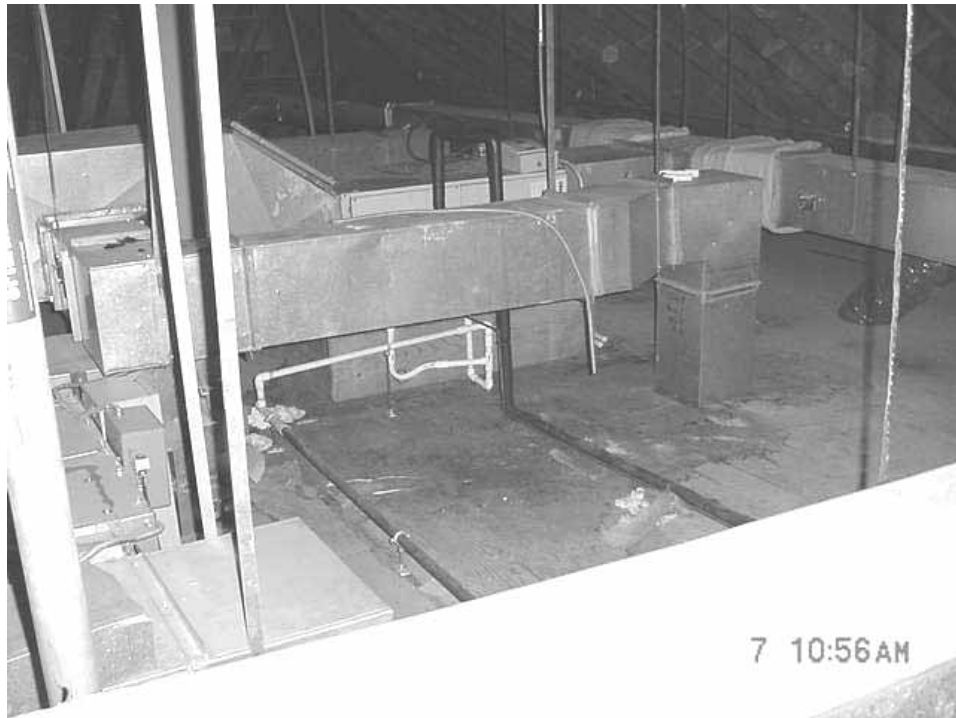
Picture 1

It can be seen from Table 1 that carbon dioxide levels were below 800 parts per million (ppm) in all occupied areas surveyed, indicating adequate air exchange. However, the WFD does not have any means of mechanical ventilation, but uses windows to introduce fresh air. Air conditioning is provided during summer months by air handling units (AHUs) located in the attic (Picture 1). The AHUs do not have the capability to introduce outside air and can only recirculate air. AHUs are ducted to wall or ceiling mounted air diffusers (Picture 2). Ceiling-mounted return vents (Picture 2) draw air back to the AHUs via ductwork. These systems were not operating during the assessment. WFD officials reported that a preventive maintenance program was in place for air handling equipment.

AHU in Attic

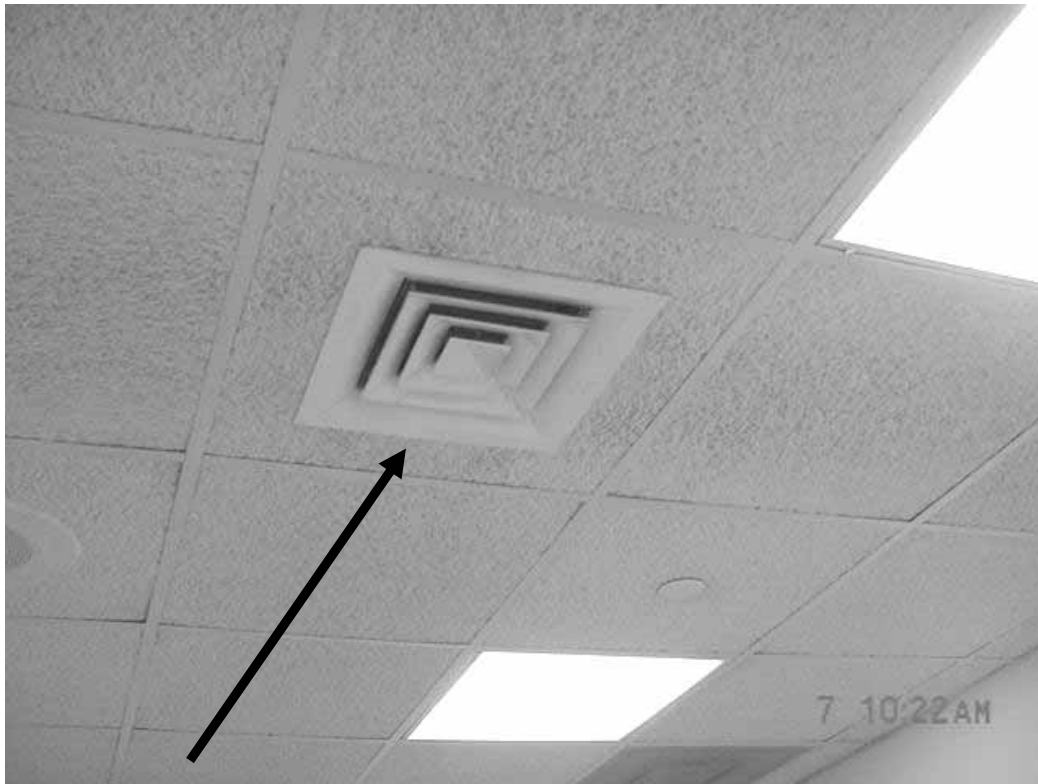
Picture 2

Supply and Return Vent for AC System

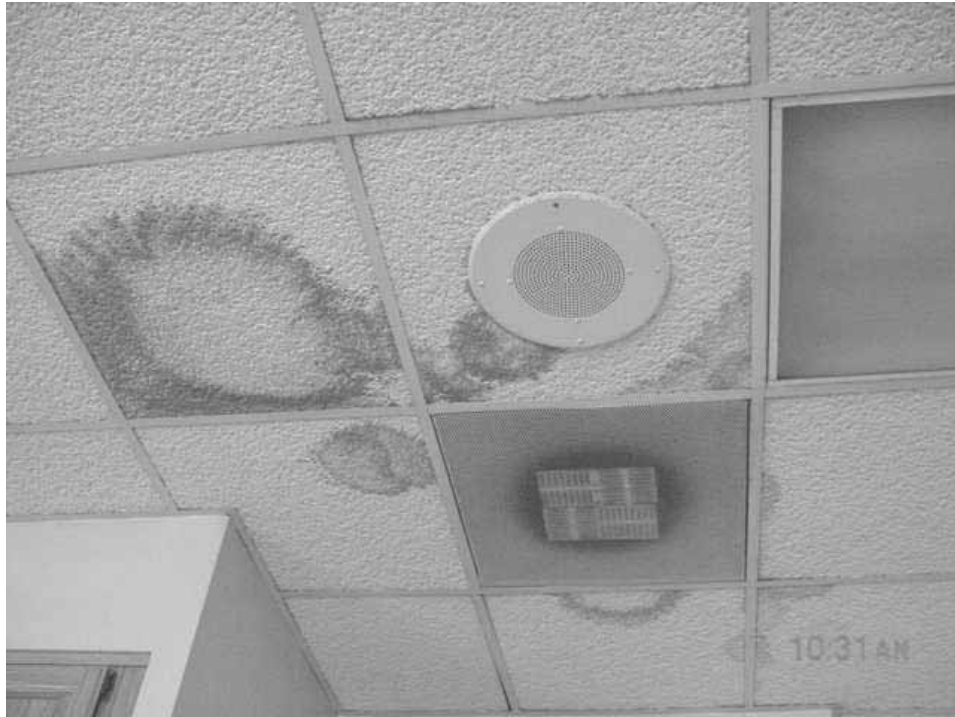
Picture 3

A number of areas had water-damaged ceiling tiles (Picture 3). Occupants reported that ceiling tiles became damaged as a result of condensation generated from operating the air conditioning equipment during the cooling season. Water-damaged ceiling tiles can provide a source of mold and should be replaced after a moisture source or leak is discovered and repaired.

Water Damaged Ceiling Tiles in Kitchen Area

9. Replace/repair water-damaged ceiling tiles. Examine the area above and behind these areas for microbial growth. Disinfect areas of water leaks with an appropriate antimicrobial.
10. Consider contacting the WFD's HVAC vendor to determine if the AC system can be retro-fitted so that fresh outside air be mechanically provided throughout the year.
11. For further building-wide evaluations and advice on maintaining public buildings, see the resource manual and other related indoor air quality documents located on the MDPH's website at <http://www.state.ma.us/dph/behav/iaq/iaqhome.htm>.

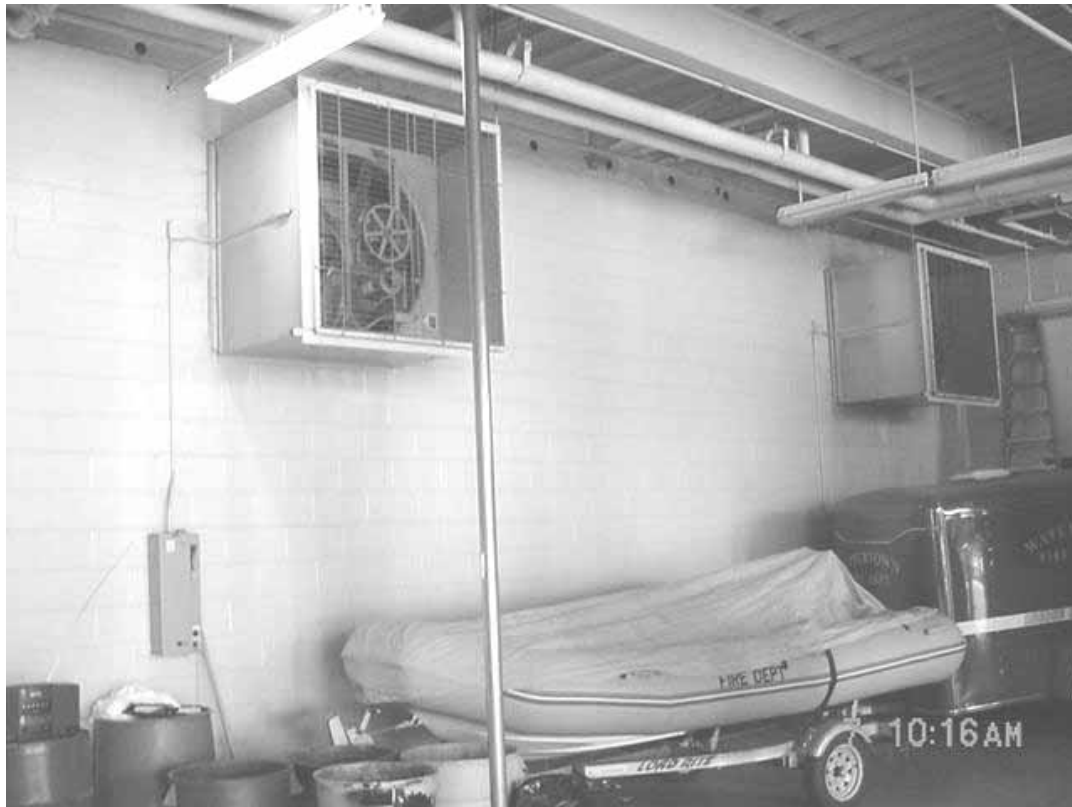
Picture 4

As mentioned previously, the station is equipped with a mechanical exhaust system to remove exhaust from the engine bays when vehicles are idled. The local exhaust system consists of two large manually-activated exhaust vents located at the rear of the engine bay (Picture 4). WFD personnel activate the system from a wall-mounted panel located at the front of the engine bay (Picture 5). WFD personnel reported that the system is typically activated when emergency vehicles are backing into the station, following an emergency response. This was observed by BEHA staff during the simulated call.

Manually Activated Local Exhaust Fans at Rear of Engine Bay

1. Consider installing an automatic control to activate the engine bay exhaust system as engine bay doors open.
2. Continue to manually operate the engine bay vent system to create negative pressure in the engine bays. To help reduce exposure to airborne pollutants/particulates, activate the system upon departure and returning from emergency calls.

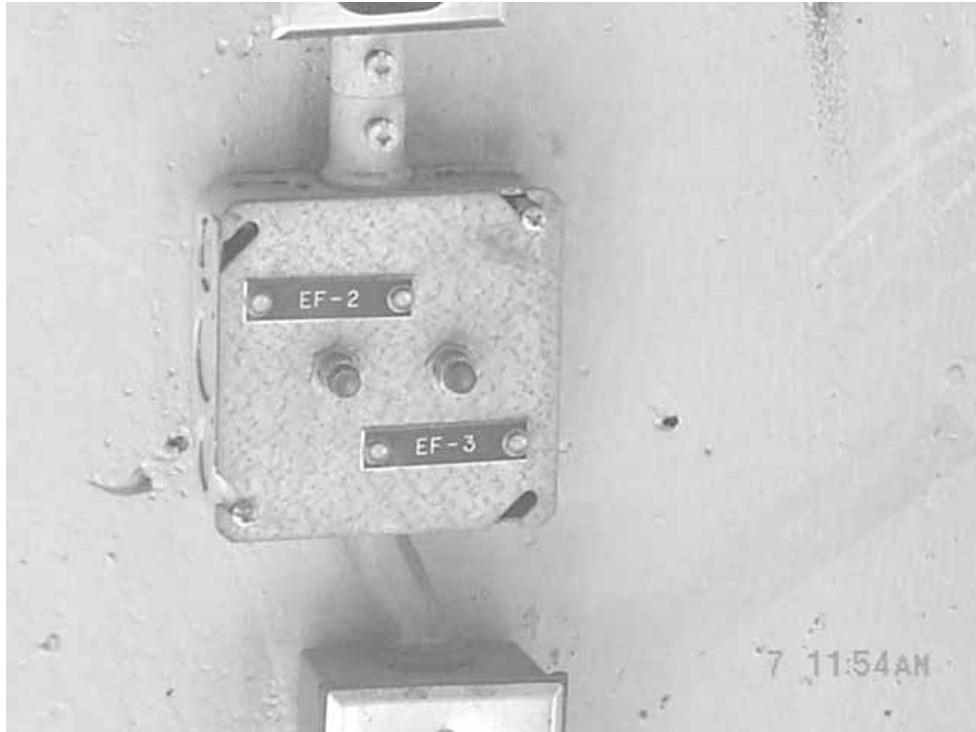
Picture 5

Activation Panel for Local Exhaust System Located at Front of Engine Bay

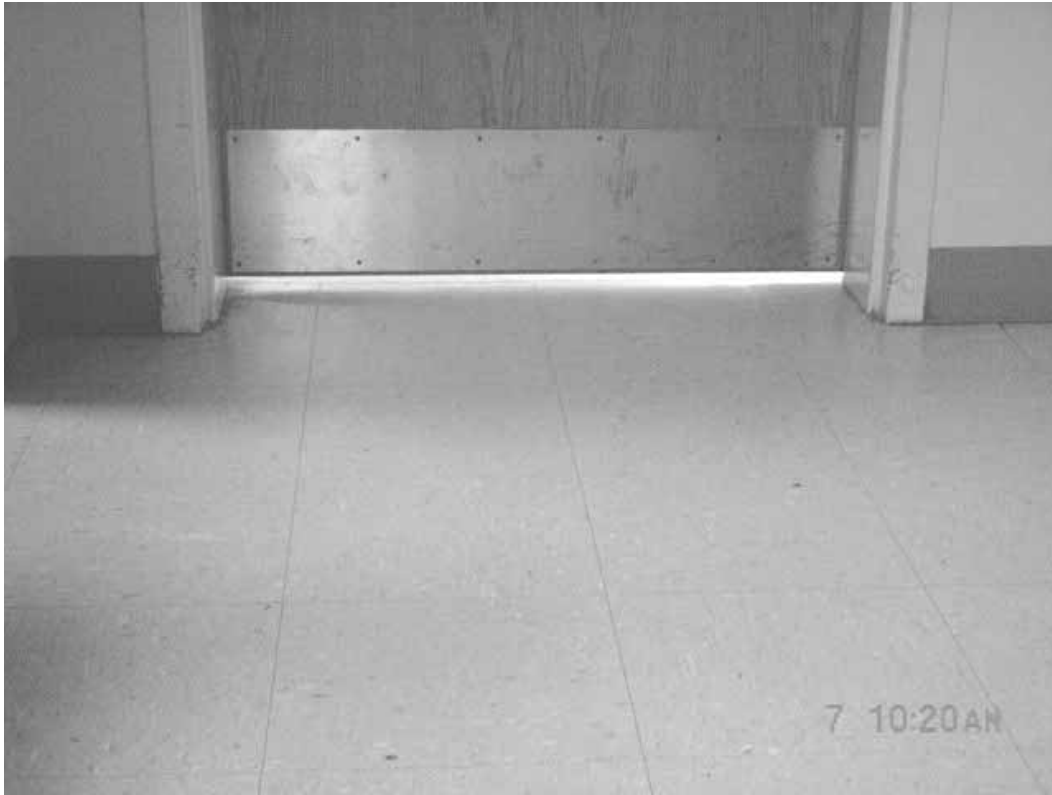
Picture 6

Example of Space beneath Engine Bay Door

3. Ensure all doors are closed when accessing engine bays.
4. Ensure doors around engine bays are completely flush with threshold. Seal doors on all sides with foam tape, and/or weather-stripping. To create a dual barrier, consider installing weather-stripping/door sweeps on both sides of doors that provide access to the engine bay. Ensure tightness of doors by monitoring for light penetration and drafts around doorframes.

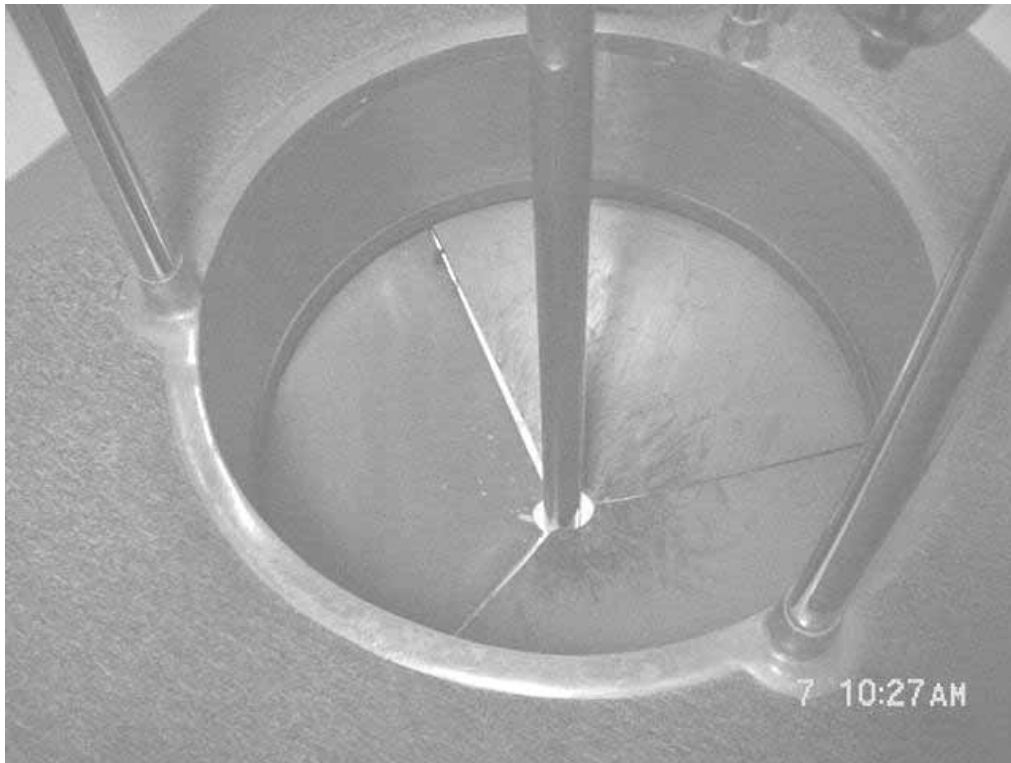
Picture 7

Spaces around Fire pole Clamshell Closures

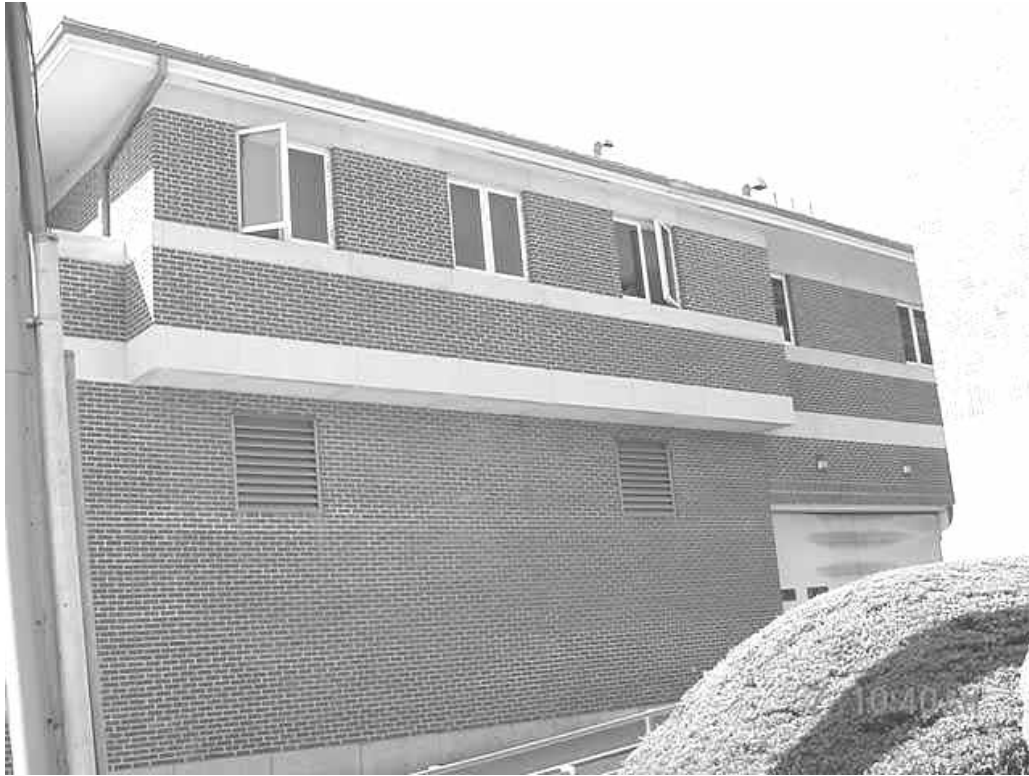
Picture 8

In addition, the second floor windows located directly above local exhaust vents were open during operation of fire fighting vehicles (Picture 8). Under certain wind and weather

conditions, exhaust emissions can penetrate or be drawn in/entrained through the open windows. Another possible pathway for exhaust emissions to migrate is through utility holes. The ceiling/walls of the engine bays are penetrated by holes for utilities. These holes can present potential pathways into occupied areas if they are not airtight. Each of these conditions presents a potential pathway for air to move from the engine bays to occupied areas of the station. In order to explain how engine bay pollutants may be impacting the second floor and adjacent areas, the following concepts concerning heated air and creation of air movement must be understood:

Open Second Floor Berthing Area Windows Directly over Local Exhaust Vents

5. Ensure second floor windows are closed during engine operation to prevent entrainment of vehicle exhaust.
6. Consider installing an exhaust vent stack for the engine bay exhaust system that extends over the height of the roof, as depicted in Picture 9. Please note that the Massachusetts Building Code states that vents removing pollutants must be either ten feet from or two feet above the fresh air intake of the ventilation system (SBBRS, 1997; BOCA, 1993).

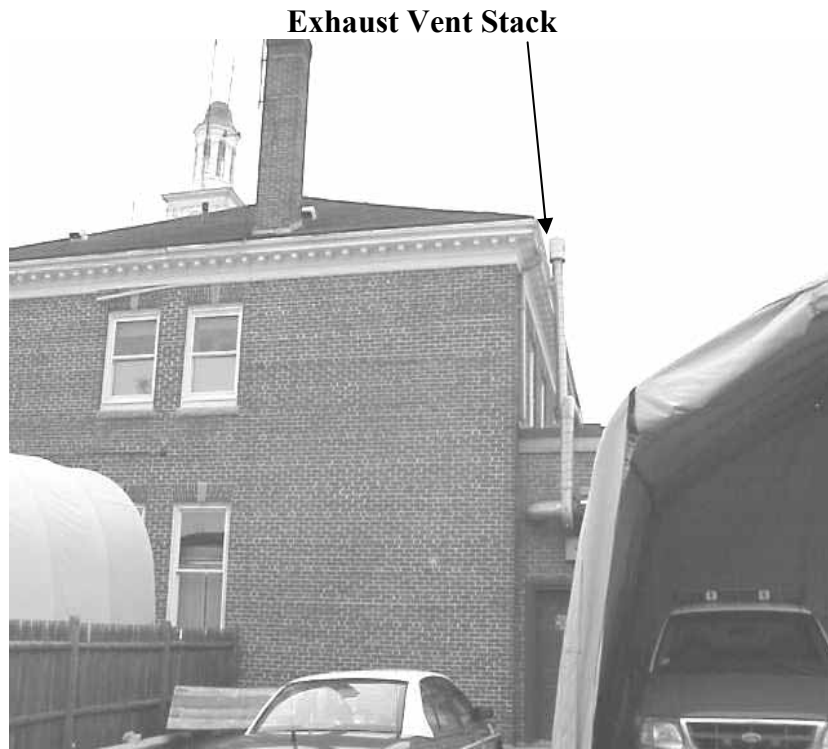
Picture 9

Vehicle Exhaust Vent (40 West Central Street Firehouse, Franklin, MA), Note the Position and Height of Vent away from Windows at rear of Building
